Help Sheet 1

RF Feedback

bhi

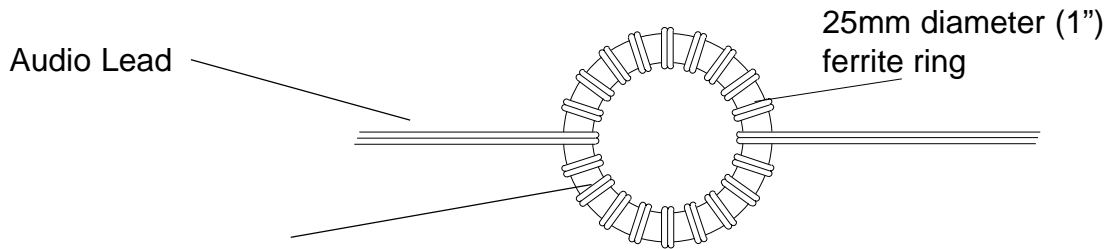
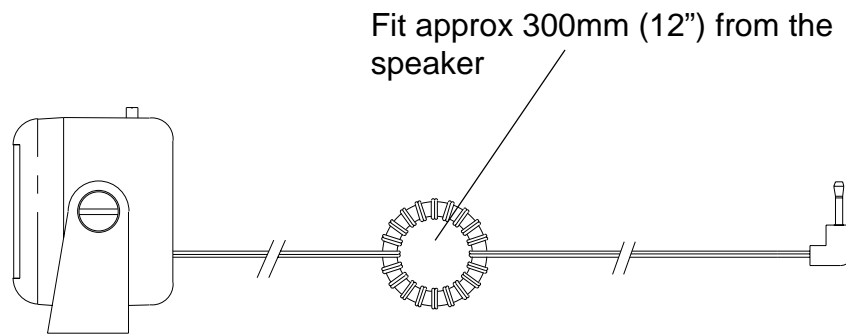
Figure 1.
Ferrite ring winding detail

All bhi products will operate correctly under normal working conditions. However if problems with feedback are experienced during transmission then the following help sheet has been prepared to help resolve this problem.

Wind as many turns as possible around the ferrite

Try transmitting again. If the problem persists , then move to step 2.
